**Aerospace
Systems Division**

Apollo 15 Anomalies Investigation

ATM 1060

The purpose of this ATM is to review and status the BxA effort with respect to the Apollo 15 Anomalies Investigation.

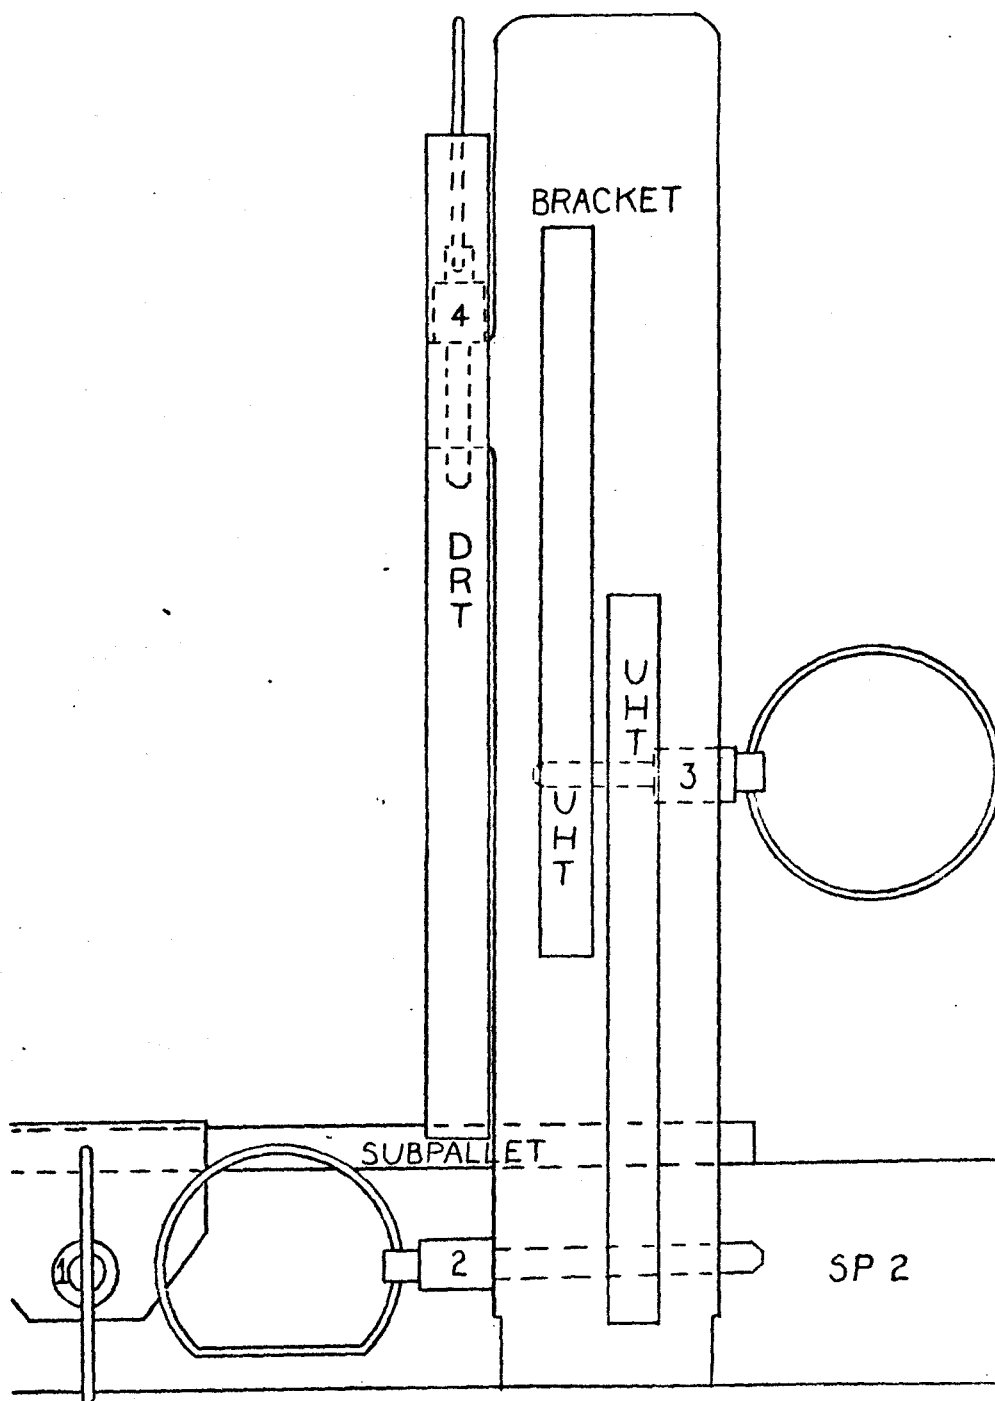
Figure #1 Front View of UHT Stowage

Figures #1 and #2 depict the front and side views, respectively, of the stowed UHT/Subpackage #2 interface. The four pull pins located at or near this interface are enumerated as follows:

Figure #1 illustrates that pin #1 must always be removed prior to pin #2 and hence we may speak of a pin #1/2 combination. This produces 3 factorial pin pulling permutations, as follows:

Therefore, from all the available evidence, it would appear that the CDR removed the DRT, UHT and subpallet pull pins, but not the tool bracket pin, and then attempted to remove the UHT's and experienced a hang up of the UHT's in the front tool bracket. This was the result of a procedural error. The tool bracket should be released before unstowing the UHT's. The degree of difficulty experienced could not be duplicated in testing, nor can it be explained based on the available evidence. Whether pin pulling sequence (b) or (f) was employed cannot be stated with any certainty.

No additional testing of this tool stowage configuration is planned. Arrays D and E each incorporates a different tool stowage approach from that used on Apollo 15. Presently planned mechanical and Crew Engineering tests, crew experience with training hardware and CF² testing, along with adherence to established deployment procedures, should prevent a recurrence of this anomaly. Crew Engineering will recommend to the flight crews (who have the decision authority) that numerical decals be used in conjunction with pull pins that must or should be pulled in a specified sequence.

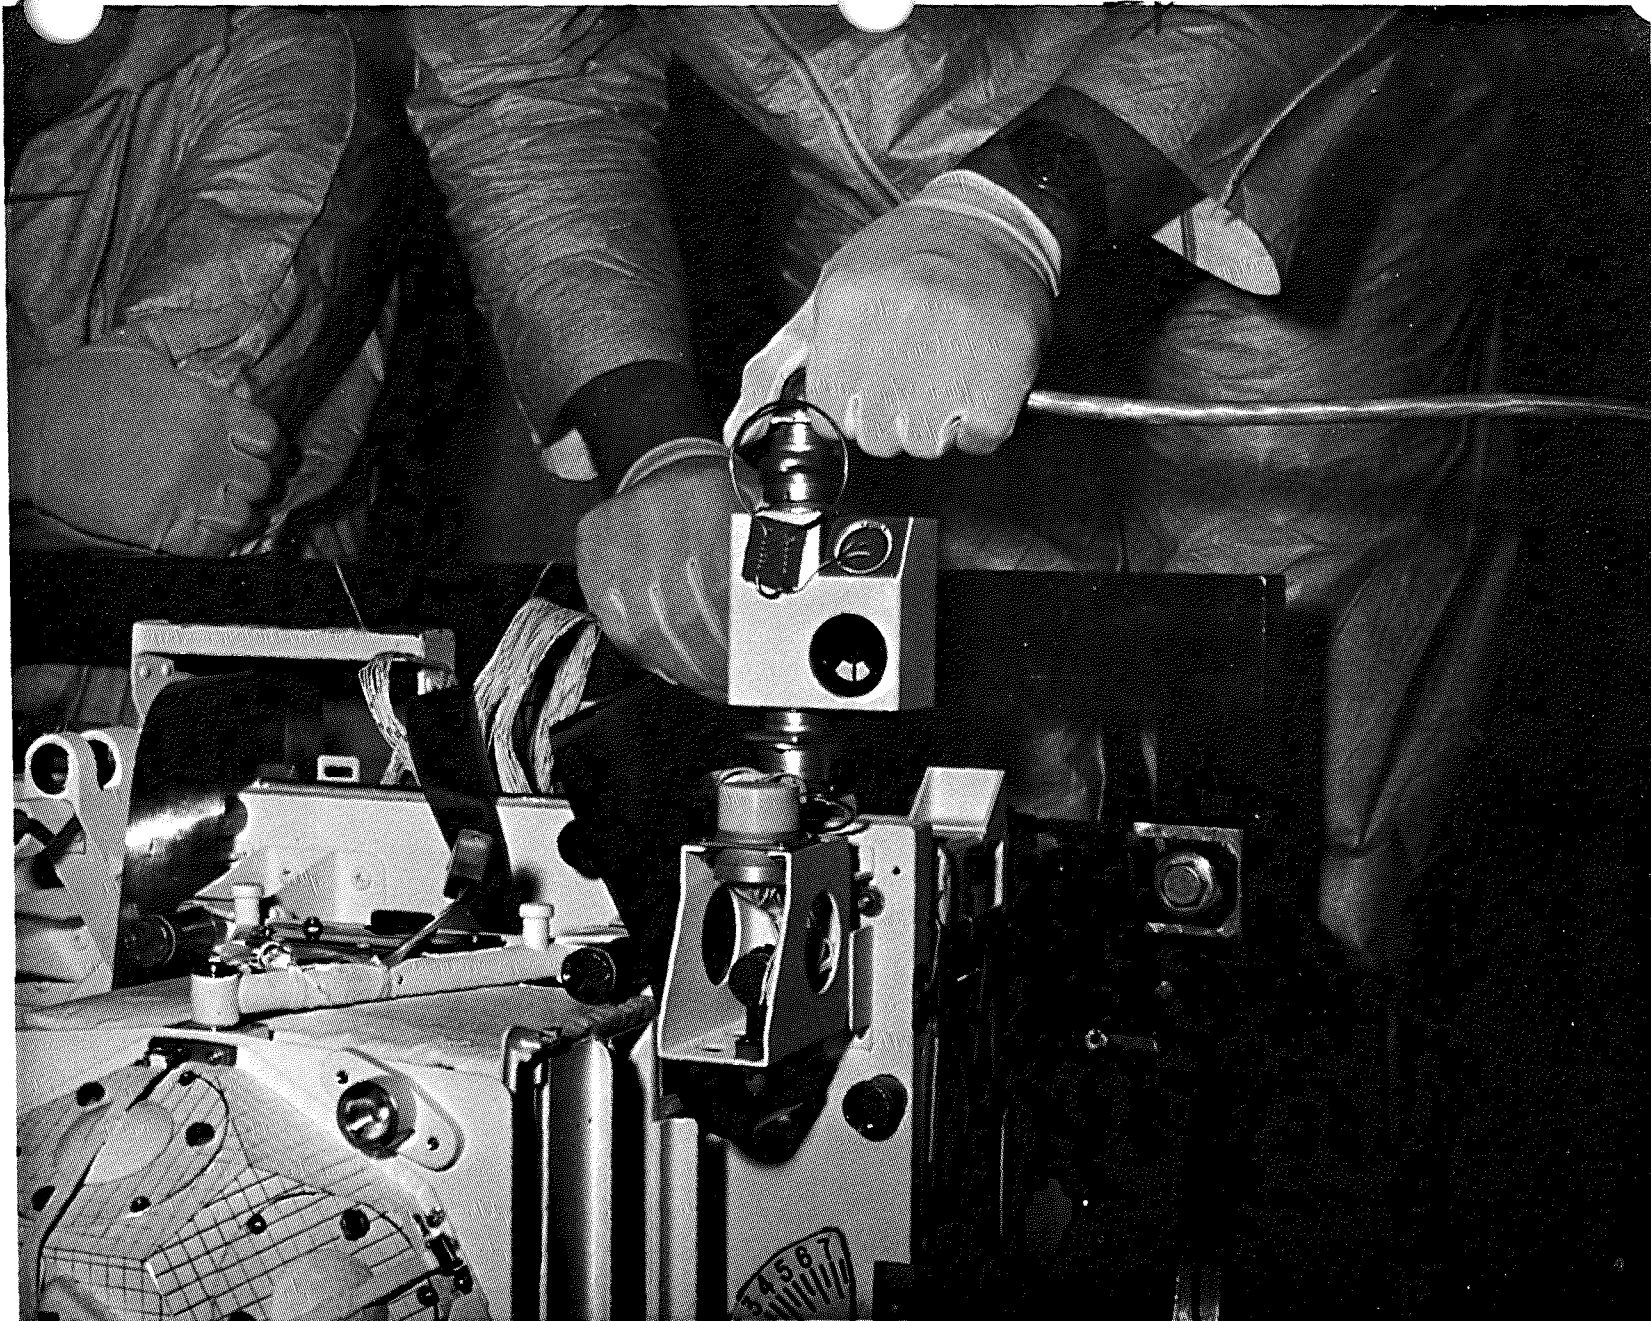
Figure 3
Shorting Switch (RTG)

The deployment procedure indicates that the LMP should report the ammeter reading on the shorting plug (which should be greater than zero), then mate the shorting plug to Central Station, and subsequently he should depress the shorting switch and visually check the ammeter to ensure that it is now reading zero. He would next turn on Astro Switch #1 and the transmitter would then be turned on.

The voice transcript indicates that the ammeter did read greater than zero prior to plug in. The reading of .8 was higher than the predicted value of .56, indicating that the RTG was putting out more current than expected. Since the transmitter automatically turns on at approximately 55-60 watts (as long as the shorting switch has been depressed) and we know that there was acquisition of signal at approximately 5 hrs., 02 min. (18:37 G.M.T.), 31 minutes after plug in (18:06 G.M.T.), we can assume the shorting switch was depressed during plug in. ~~It was not depressed prior to plug in since the .8 ammeter reading indicated that the short was still in just prior to mating.~~

The inadvertent depression of the shorting switch during plug in was shown to have occurred on Apollo 12 as well. As a result of the Apollo 12 experience a lanyard and pull ring were added to the shorting plug to permit the astronaut to reset the shorting switch and return the shorting plug to the shorted condition.

There is general agreement that the shorting switch was inadvertently depressed during shorting plug mating to Central Station. The voice transcript indicates that the LMP pulled the push button out to reinstate the short, but the fact that there was no switching from PCU 1 to PCU 2 as a result of loss of signal indicates that the push button was not pulled out or that there was a switching failure. Such a switch failure occurred in testing, was fixed, and did not reoccur during retesting. Why the lanyard actuation, assuming it occurred, had no effect is still unexplained.

are to be modified so that if the switch is inadvertently activated prior to plug in (i. e., if the ammeter reading is zero), the astronaut would pull the lanyard, read the ammeter again, and plug the shorting plug in whether the reading was zero (short removed) or greater than zero (plug is shorted). A "hot" plug in is permissible under these circumstances. If, after plug in, he reads the ammeter (this is a new step in the procedure) and the ammeter reads zero or if there is acquisition of a signal, both of which indicate that the switch has been depressed, there will be no attempt to reset the switch (this is also a change to the A-2, Apollo 15 procedure).

For Array E (Apollo 17) the shorting plug has been redesigned, in part to eliminate the inadvertent switch activation problem. The push button has been replaced by a rotary switch that is far less prone to inadvertent activation. A full test program will ensure proper functioning of the shorting plug.

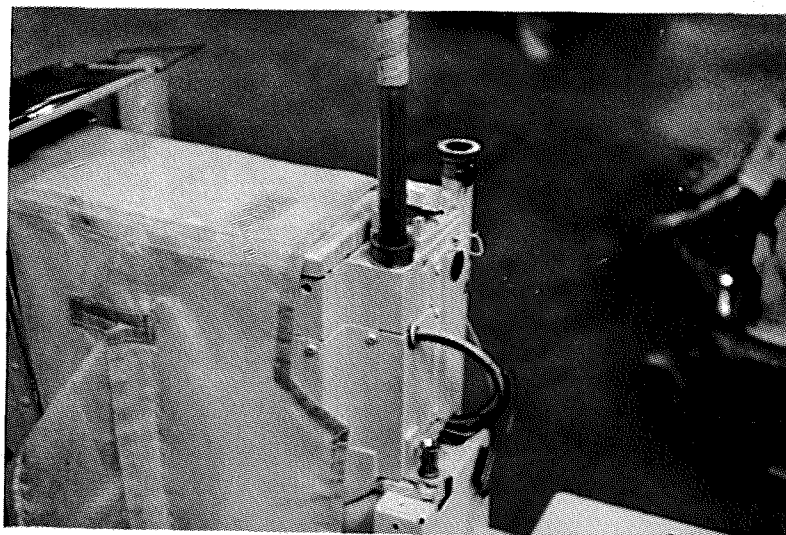
Figure #4

A test, at MSC, with the E-2A-2 Crew Training Model hardware after the flight (see Figure #4) could not duplicate the engagement difficulty or the problem of inadvertent disengagement. A CF² test of the flight hardware prior to the flight indicated that there was no problem associated with the fit checks

UHT/SIDE Interface Test

As a result, of all of the above problems, it is most likely, also based on testing, that the UHT "balls" were not fully engaged and that the SIDE fell off the UHT because of incomplete UHT engagement. Also experience in testing has shown that the crewman can inadvertently depress the UHT trigger, release the "balls" on the UHT and drop the experiment.

Since the SIDE will not fly again on ALSEP there will be no further testing of the UHT/SIDE interface. However, training experience plus CF^2 fit checks of all UHT/UHT socket interfaces should tend to prevent a re-occurrence of this problem on Apollo 16 and 17 hardware. In addition it has been recommended that dimensional checks of all Array D and E trainer and flight UHT's and UHT sockets be performed prior to shipment and that all qual and flight UHT sockets be tested with qual and flight UHT's to ensure that there is no UHT disengagement when a force equal to twice the weight of the component being tested is applied to the handle of the UHT.

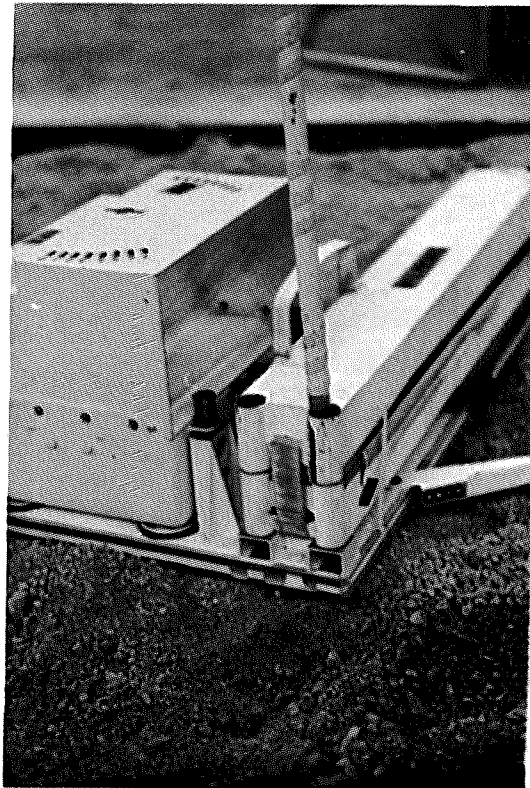
Figure #5

The voice transcript and crew debriefing indicated that the CDR had difficulty releasing two Boyd bolts, one on the HFE Electronics Package and one on the HFE Probe Package. Similar difficulties have been encountered in the past during testing, crew training and on the lunar surface. Most of the earlier difficulties with Boyd bolt release were traced to improper installation and as a result improved procedures, installation tools, and increased testing and monitoring precautions were instituted to ensure as nearly perfect a record of Boyd bolt installation as possible.

It is still more likely, that the vibration of launch or lunar descent might have caused a binding in the Boyd bolt fasteners that led to the difficulty experienced by the crew. Such a "sticking" of Boyd bolts has been encountered in past testing and, as a result, the contingency procedures for Apollo 15 were modified to recommend that if a Boyd bolt spindle would not freely depress that the crewman should attempt to rotate the UHT several degrees clockwise and then continue with the standard Boyd bolt release sequence. This contingency procedure has been found to be highly effective. Other contingency procedures for other potential malfunction modes, plus the fact that the two Boyd bolts did release after some extra effort by the crew, indicate that the present Boyd bolt design, installation and testing is adequate.

HFE Boyd Bolt Test

Other than the presently established procedures and testing for all Array D and E Boyd bolts, no additional testing, etc. is planned. Additional efforts to familiarize the flight crews with Boyd bolt contingency procedures is recommended for Apollo 16 and 17.

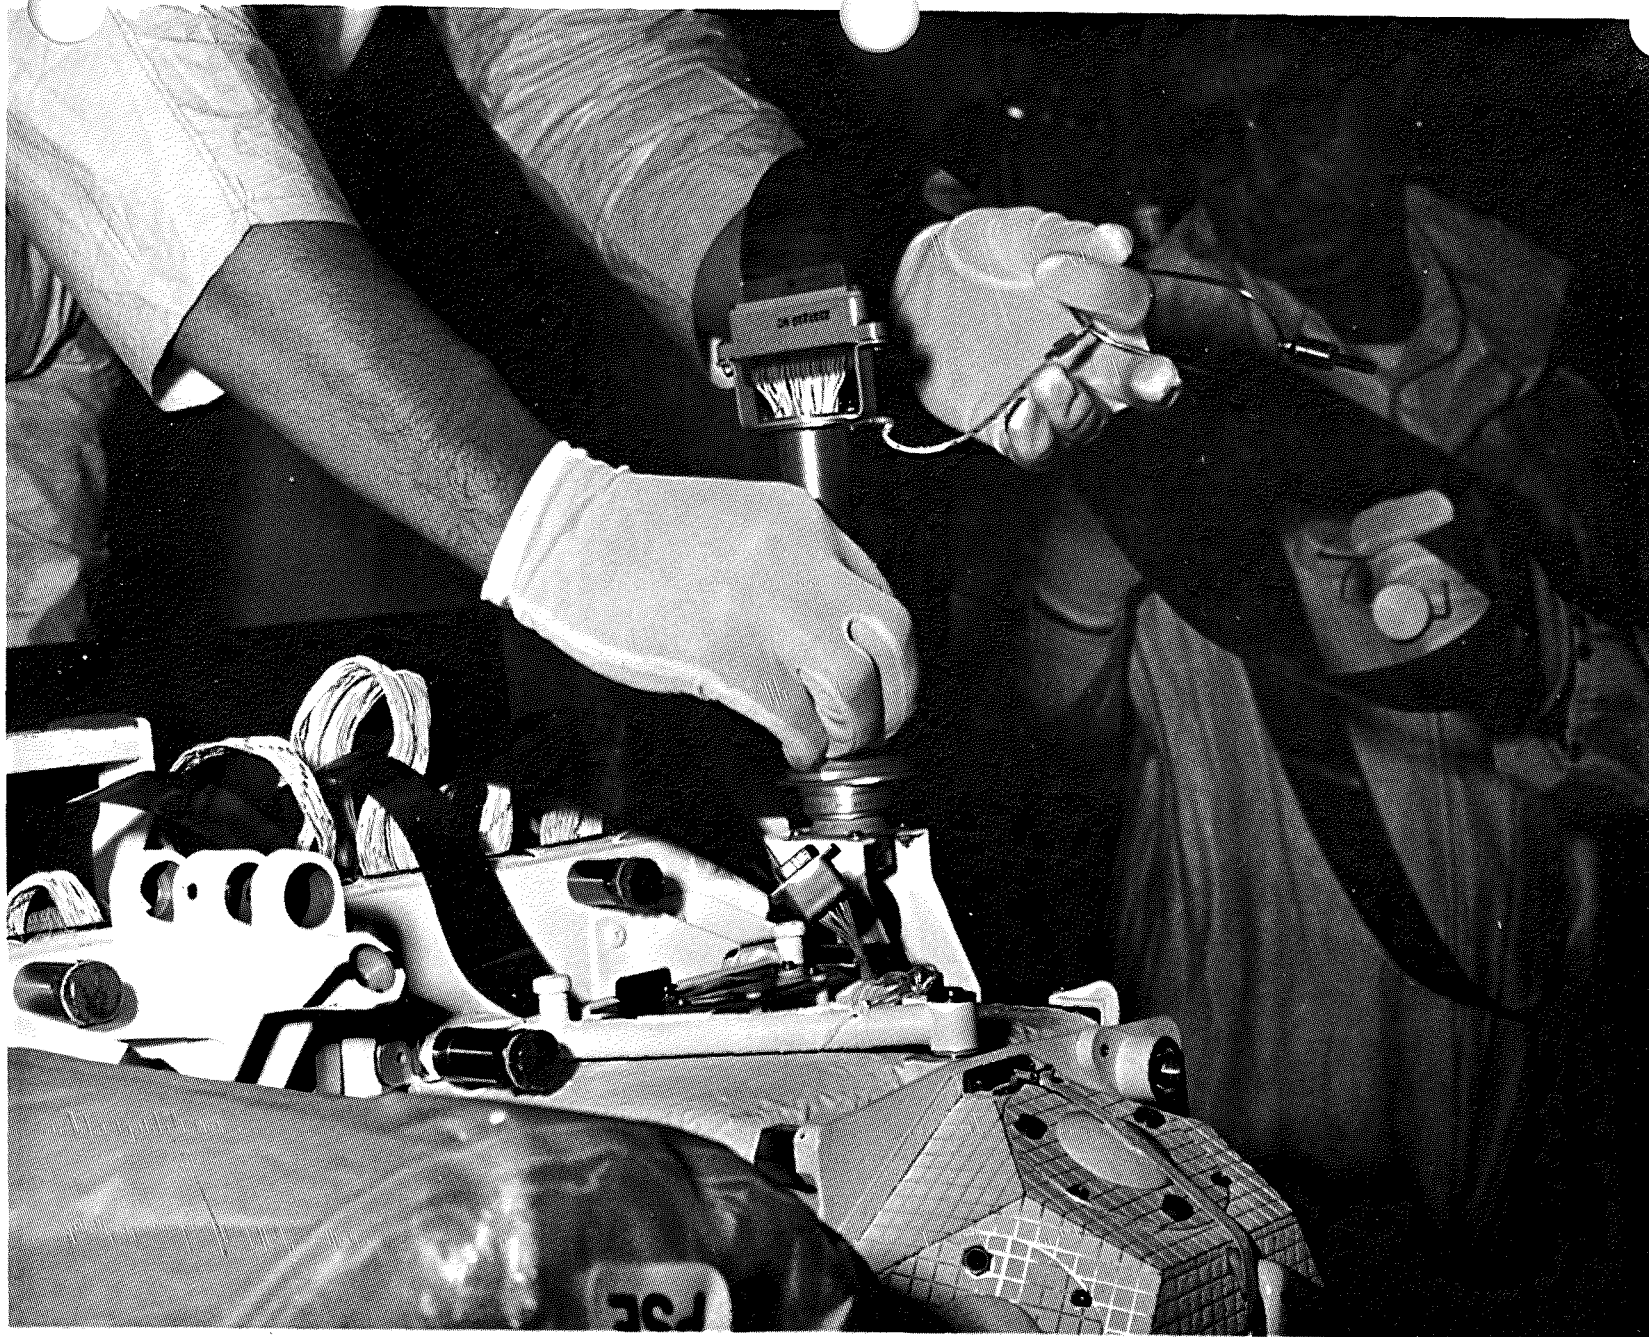
Figure 6
SIDE Connector

Tests were performed at BxA using Crew Engineering test hardware. The tests indicated 15 to 17 pounds force (15.6 pounds mean) was required to mate the RTG (Deutsch type) connector and 18 to 20 pounds force (19.2 pounds mean) was required to mate the HFE (Microdot type) connector. No tests were performed on the SIDE (Deutsch type) connector because of the unavailability of suitable hardware for the test. However, it can be fairly stated that the engagement force to be expected from the SIDE connector (37 pins) will tend to be higher than that measured on the RTG connector (27 pins) since engagement force tends to increase with a higher number of pins.

Finally, the shape of the SIDE connector handle (tubular) and the orientation of the handle (in line with the direction of push-to-mate) make the engagement task somewhat difficult.

In addition the type of handle that was used on the SIDE connector will not be used on future flights. "U"-shaped handles, which have proven to be a suitable interface for grasping during connector mating will continue to be used on the HFE, as well as on the LEAM. The two "ears" that are grasped with both hands in order to mate the RTG connector, that have caused some difficulty in the past, are being replaced with a "T" handle on Array E ALSEP, which should provide better, one-handed control for RTG connector mating. Finally, all the connectors used on Apollo 17 and 16, with the exception of the old style RTG connector used on Apollo 16, will have secondary rotational locking features, in addition to the push to engage feature, to ensure against accidental disengagement of the connectors.

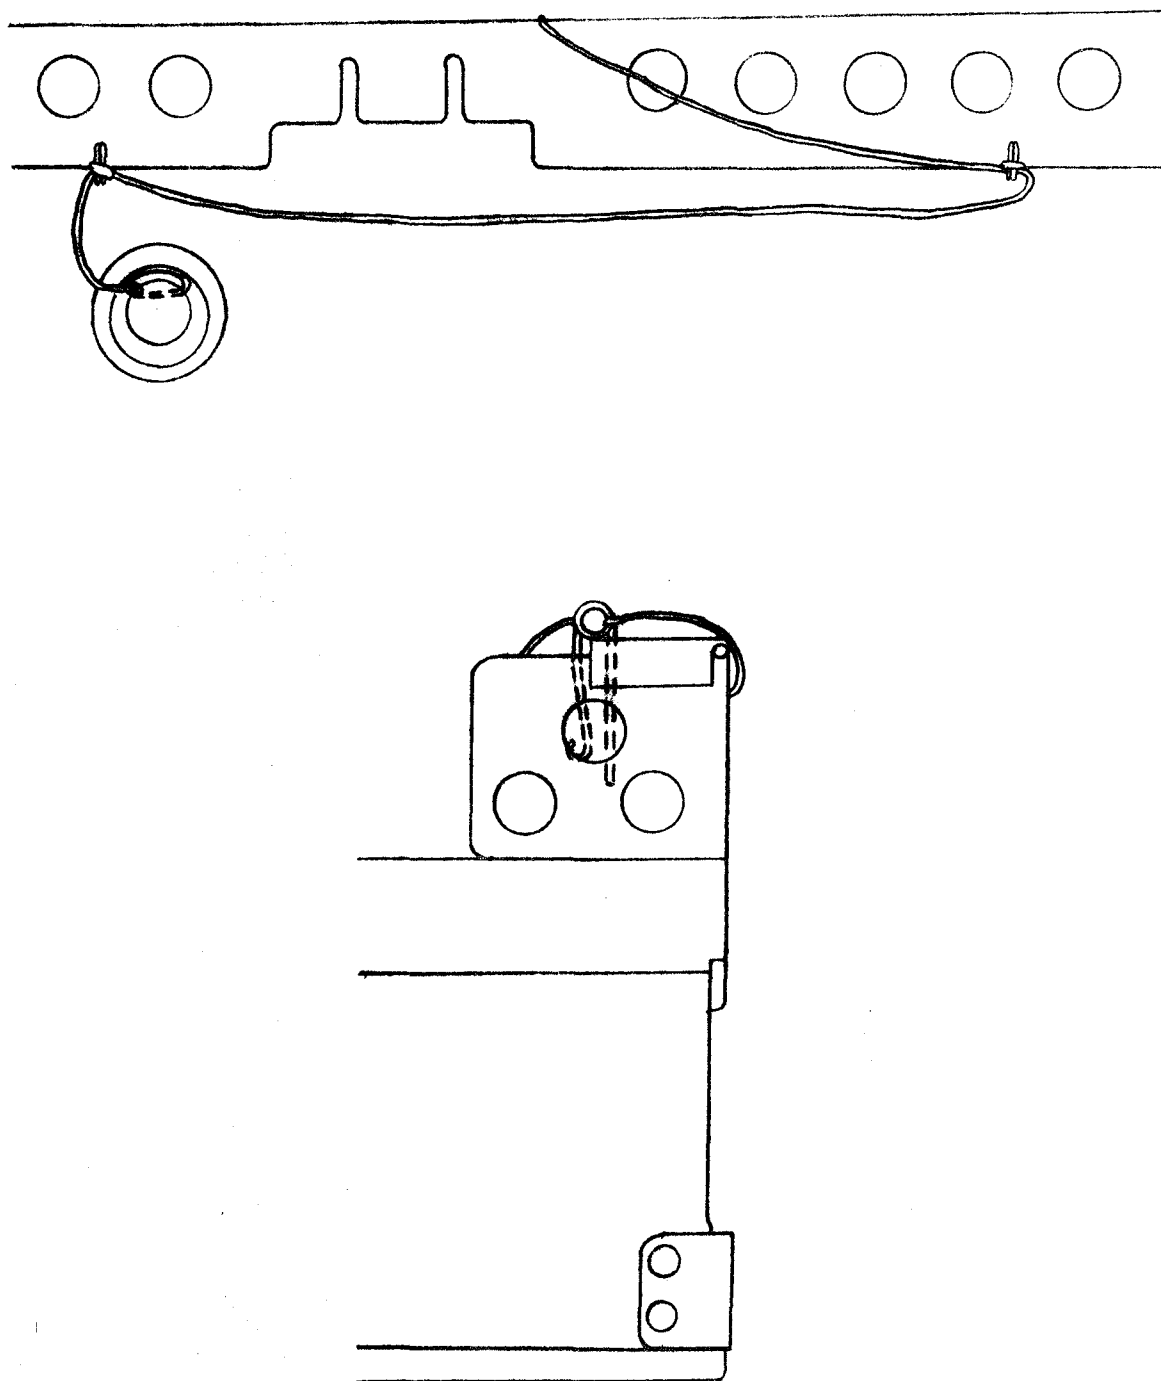
Almost all the breaks (about 95%) occurred within the knot assembly, presumably because of stress concentrations within the knots. This would explain the breaking strength being less than the rated strength of the lanyards. The 40 pound proof testing (done in conjunction with the 180 pound test lanyards and pip pins) would consistently have failed the 50 pound test lanyards based on these tests. Other results include the fact that "slip" knots were not as strong as "bowline" knots. Also none of the knots became untied,

Figure 7 Top and Side Views of Rear Curtain Cover,
Lanyard, Pins and UHT Socket

Based on the Apollo 15 experience, analyses and the tests that were already performed, the 50 pound test lanyard used on the rear curtain cover has been replaced by a 180 pound test lanyard on Array D. There is no lanyard in the Array E curtain cover design; hence no replacement was required. The 50 pound test lanyards used for the contingency removal of pins on the Array E carry bar design (no lanyards are present on the Array D design) have been replaced with 180 pound test lanyards.

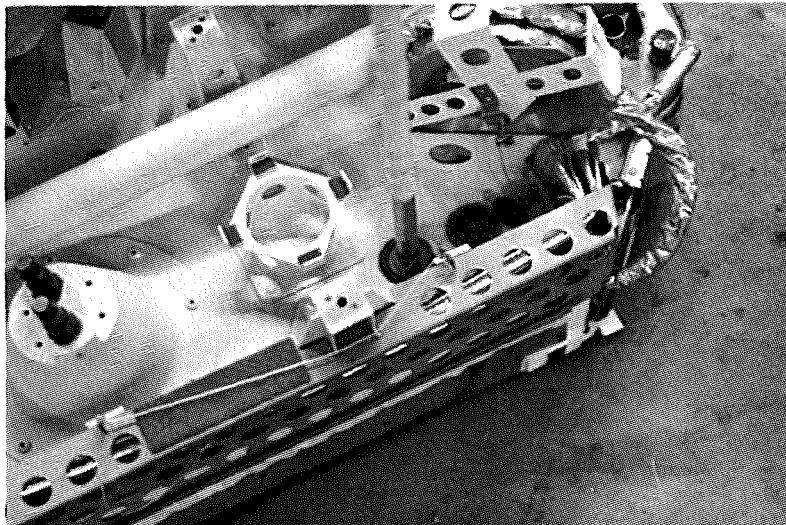
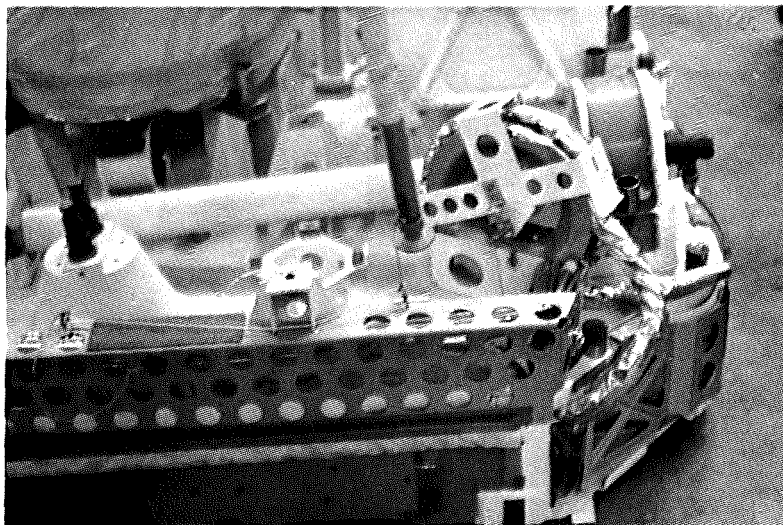
Figure # 8

After the lanyard failure on Apollo 15, a test was performed at MSC using the E-2A-2 Crew Training Model (see Figures 8 through 10) in an attempt to duplicate the Apollo 15 experience. The nominal and contingency deployment modes were repeated but there was no failure experienced. This test, which was run at ambient temperatures, was consistent with a calculated temperature of 74°F for the rear curtain cover at the time it failed. (Empirical data from thermistors on the flight hardware indicated a temperature for the curtain cover in the neighborhood of 62°F, based on a reading from a thermistor located on a proximate Central Station surface.)

Rear Curtain Cover Test:
UHT Engagement and Removal of First Pin

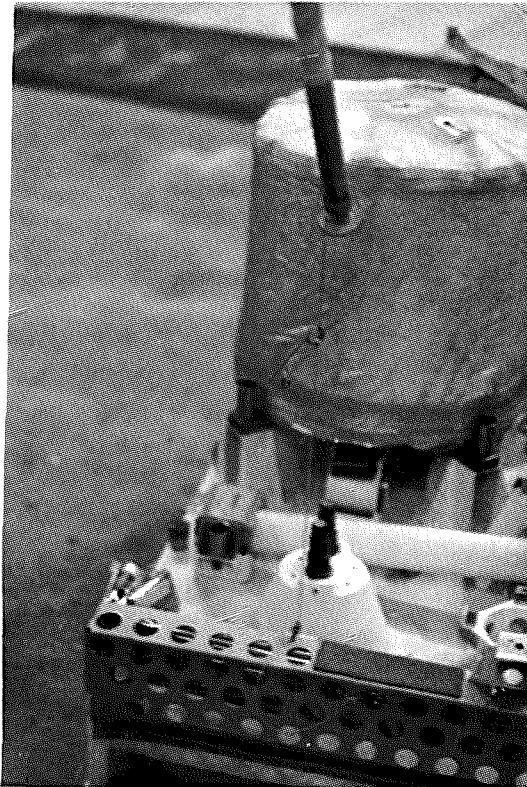
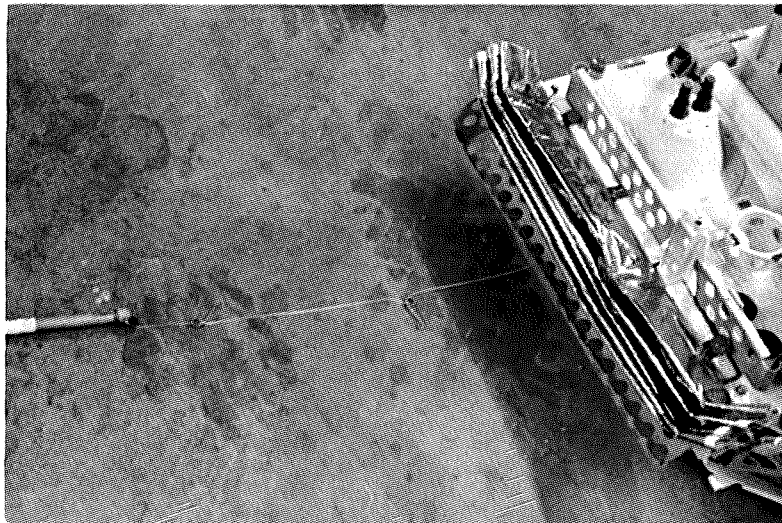
Figure #9

Rear Curtain Cover Test:
Removal of Second Pin and Removal of Curtain Cover

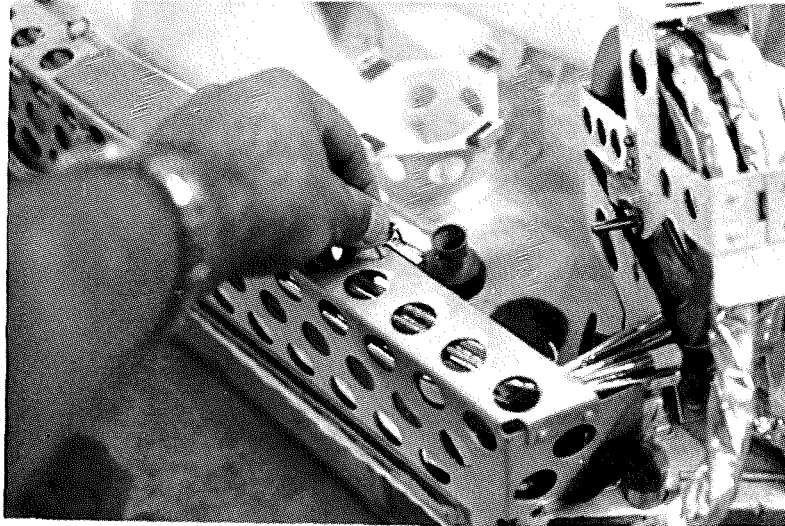
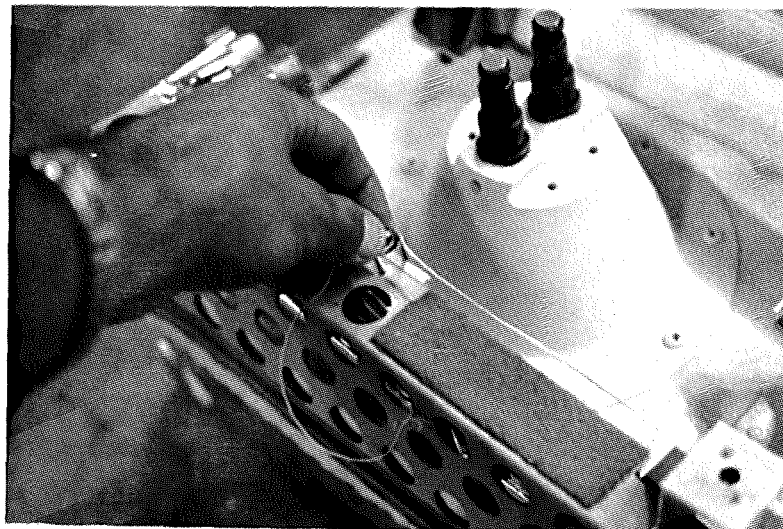
Figure #10

Rear Curtain Cover Test:
Manual Removal of Curtain Cover Pins
